Hunting Caye

**Overview of Recommendations
for
Environmental Best Practices**

Wildtracks
Conservation, Education and Research

Hunting Caye – Overview of Recommendations for Environmental Best Practices

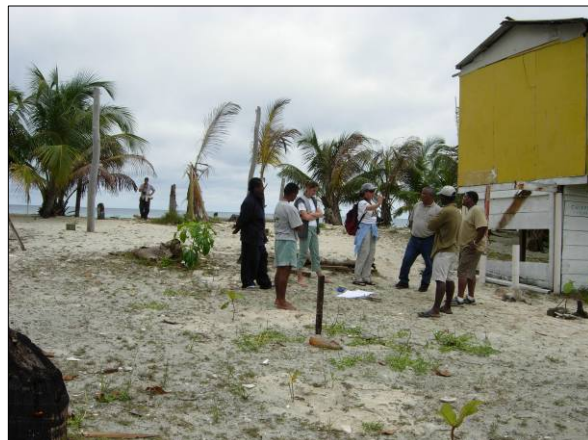
Photograph Two: Construction Site
Wildtracks

The construction site has been heavily impacted in the past, and currently has no natural vegetation (Photograph Two). The construction will therefore not require any clearance of littoral forest or beach vegetation. In terms of this critical ecosystem, therefore, considerations

regarding the development of the Living Reef Centre can be based largely upon rehabilitation of this ecosystem from current and past impacts, rather than just on possible negative impacts resulting from construction.

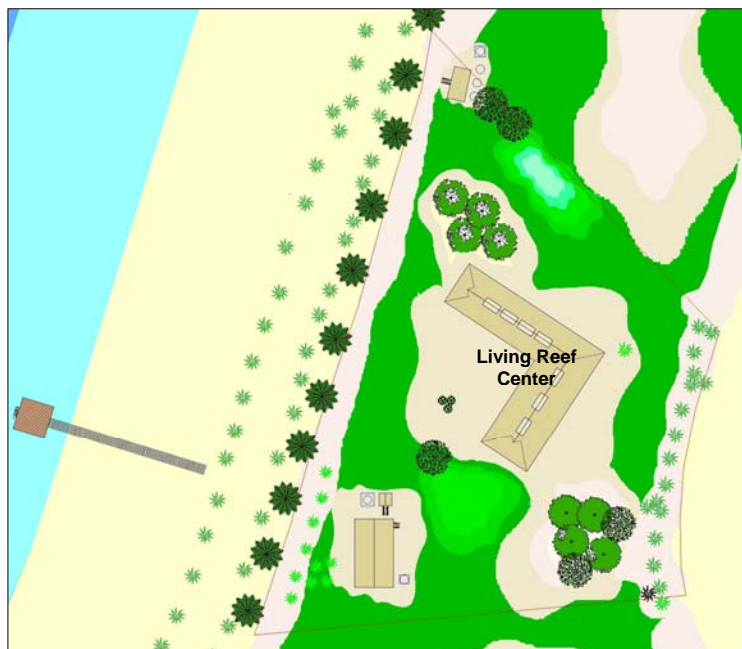
Diagram One:
Plan of Living Reef
Center, Hunting Caye

Adapted from: Sheldon
Mahung. (Architect),
for: The University of
Belize & Earthwatch
Institute

- Potential impacts during the operational stage include the impacts of light on turtle nesting and hatching (particularly on the Critically Endangered hawksbill), and the impacts of visitor behaviour (whether students, volunteers or researchers) on both the nesting turtles and the surrounding reef. Rotating the building (Diagram One) should focus the majority of the activity on the western side, away from the turtle nesting beach.

- The building should be set back 20m from the eastern beach ridge, and rotated (Diagram One), whilst still capturing the breeze in the accommodation area.
- Native vegetation should be used to screen the building lights from the nesting beach, with paths (one to the east, one to the west) angled to avoid straight line of sight from the beach to the lights of the building.
- Where possible, solar and wind power should be utilized. Whilst the preferred option is the installation of a combined system of solar power and wind generator, the cheaper option is a diesel-powered generator, with greater potential for negative environmental impacts. If a generator is to be used in nesting season, potential negative impacts of

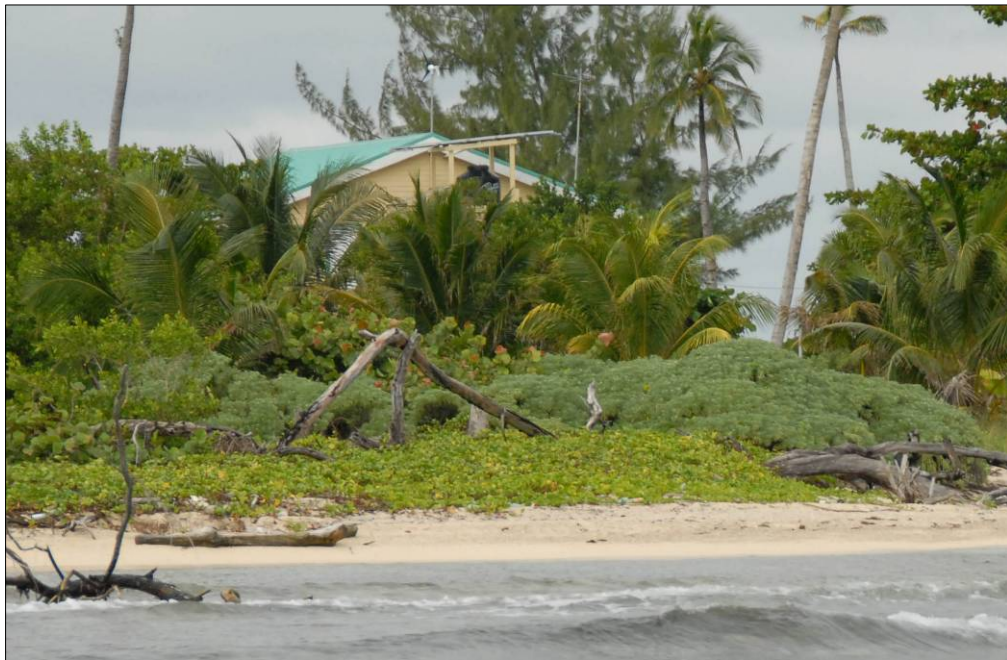
Photograph Three: Example of vegetation screening beach from light impacts
Wildtracks

- All lighting for the building should be chosen and positioned with visibility from the nesting beach in mind. (See Witherington B. E. and R.E. Martin. 1996; Cathi Campbell site report)
- If exterior lighting is considered necessary, it should be placed on the western side of the building, with screening from the eastern beach, either by the building itself, or by vegetation (Photograph Three; Annex One)

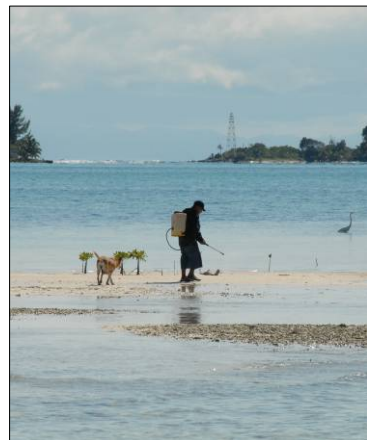
Photograph Four: Spraying in the Sapodilla Cayes Marine Reserve, Wildtracks

Spraying or fogging (typically with Malathion) against biting insects should not be permitted outside buildings. Spraying against sand-flies was observed during the site assessment – including over shallow water (Photograph Four). Such practices are wholly incompatible with the conservation mandate of the Sapodilla Cayes Marine Reserve, and should never be tolerated within the University of Belize property. It is recommended that stakeholders collaborate in the conservation of the Sapodilla Cayes Marine Reserve, and should lobby for and implement a complete ban on such highly negative management practices on any of the islands within the protected area, an initiative the management of the station should fully support.

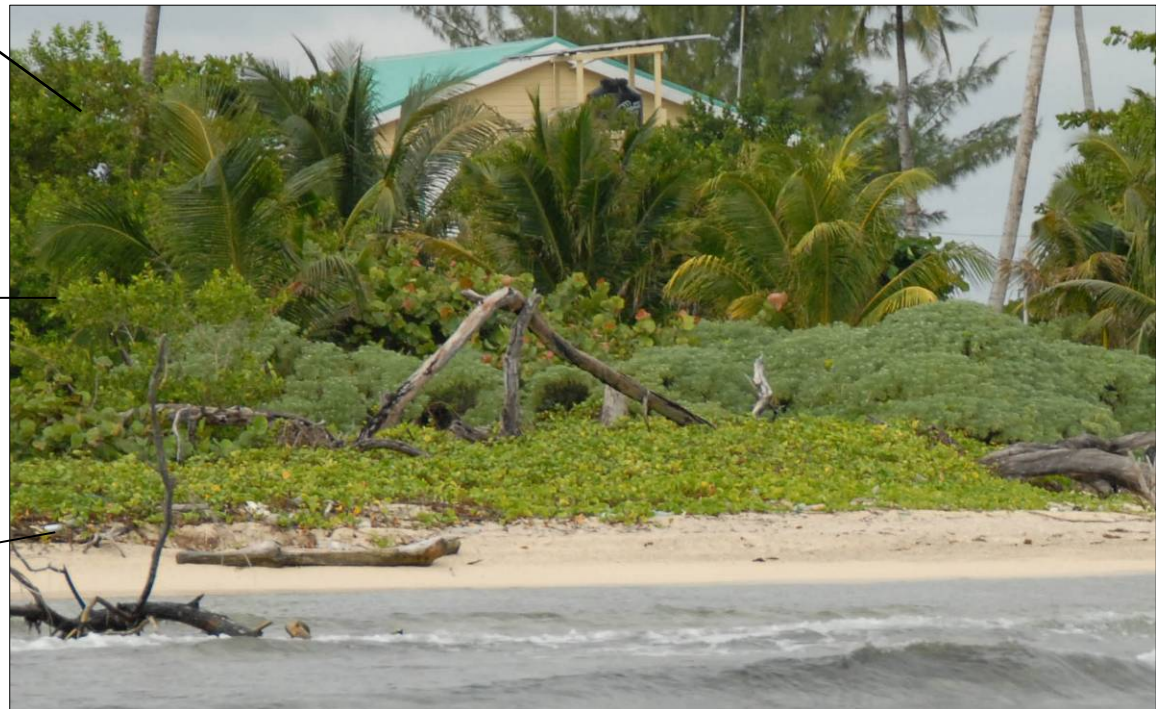
Vegetation Barriers

1. High screening trees

Native seagrapes, saltwater palmetto, and introduced coconut palms form a visual barrier, shielding facilities from other visitors on the west beach, and screening the turtle nesting beach from light impacts

2. Mid-level bushes

Shrubs such as the West Indian sea lavender and bay cedar provide a low, thick barrier between the beach and the building.

3. Low beach vegetation

Loose rooted vines and low growing plants that grow on the sandy beach ridge. These are essential for hawksbill nesting
